Cylinders troubleshooting

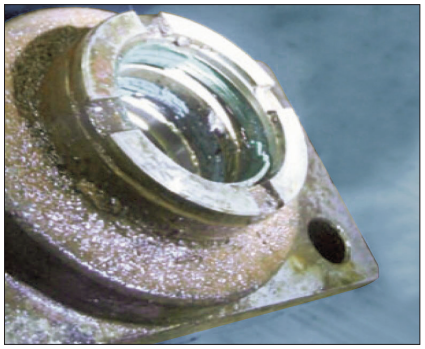
1 EXTREME TEMPERATURES

Trouble description: very high or low temperatures may cause the seals overheating or freezing, thus the loss of elastic properties and oil leakages. High temperatures make the seals dark and flaked, low temperatures make the seals brittle with heavy damages and may cause breaks in the most stressed and exposed components.

Action & prevention: standard sealing systems satisfy a wide temperature range from -20°C to 120°C, it is mandatory to respect the temperatures reported in the technical tables. Max admitted temperature for Poliurethane **G1** and PTFE seals **G4** is 85°C, for higher temperatures up to 120°C PTFE seals **G2** must be selected. Lower or higher temperatures impose a cylinder design review, contact Atos technical office.

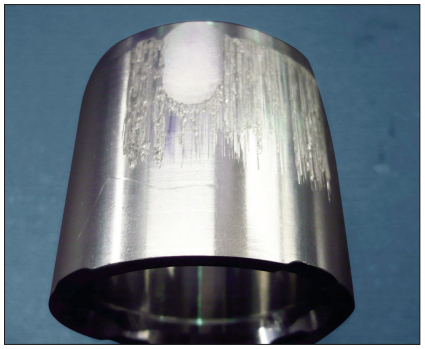
2 FLUID CONTAMINANTS

Trouble description: contaminated fluid is one of the main causes of seal leakages. Abrasive particle contamination is evidenced by scratch and score marks on the seals, rod bearing and cushioning piston with consequent leakages and loss of cushioning effect which place the cylinder out of service.

Action & prevention: hydraulic circuit must be provided with appropriate filters (at least 25 µm) to grant a contamination class lower than ISO 19/18/15 according to ISO 4406. Take care to grant adequate recirculation of the oil flow.

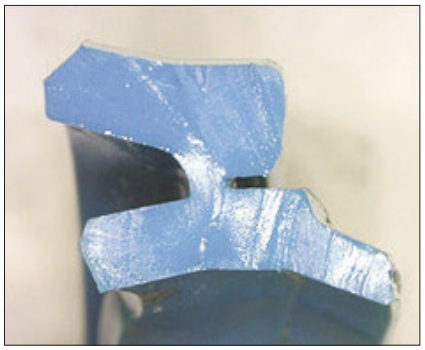
3 OVERPRESSURE

Trouble description: excessive flow restriction in the hydraulic circuit or mechanical rod shocks could involve peaks of pressure which stress rod seals and give rise to rapid seal wear and leakages. The seals appears with abnormal wear and, in the worst cases, extruded.

Action & prevention: hydraulic circuit must be designed to avoid flow restrictions which could involve dangerous peaks of pressure. A PTFE sealing system **G2**-**G4**-**G8** should be preferred if the peaks of pressure cannot be reduced, contact Atos technical office.

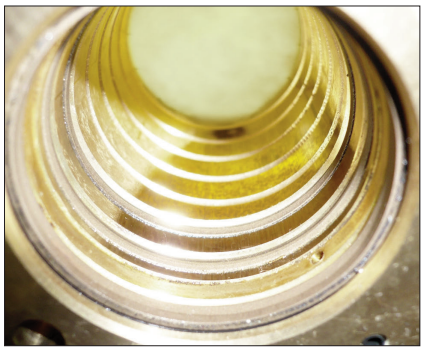
6 HIGH LATERAL LOADS

Trouble description: cylinders are designed to provide axial force and motion to a guided load, the result of a poor alignment is the excessive side loading of the rod, which involves a premature wear of the bronze bushing, seals and wear rings. Bronze bushing presents a glossy area on one side, seals and guide rings are heavily worn.

Action & prevention: the perfect alignment cylinder-machine should be ensured, pivoted mounting style, such as **C**, **D**, **S**, **G**, **H** and **L** must be preferred to rigid coupling. Particularly the **S** mounting style is equipped with spherical bearings to grant best reliability also in front of small misalignments of the cylinder mounting. For cylinders with long strokes (> 1000 mm) in horizontal applications and not guided loads, the use of well sized spacers (options **2**-**4**-**6**-**8**) is mandatory to decrease the specific pressure on the guide rings.
